Manhole Inspection Summary

Manhole # S41AA_025MH

Insp Date: 11/11/08 3:30 PM

Location Address: **1214 e madison st**

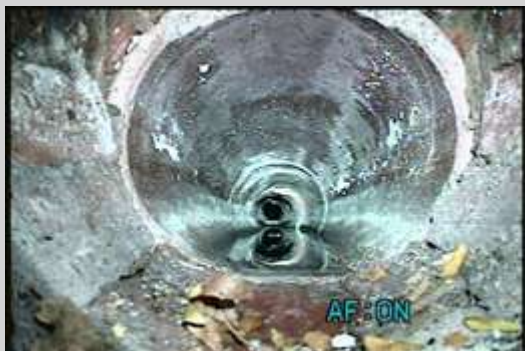
6 O'Clock Inflow

Pipe Height: 0 (in.) Direct

Pipe Material: **Clay** ☐ Pipe Lined

Infiltration: **None** Pipe Seal Cond: **Unknown**
